Final Inspections and Analysis Summary

Phase One Hydraulic Fracturing and Flowback Operations

Trinity TCC Site – 7504 Pleasant Run Road

City of Colleyville Oil and Gas Well Drilling and Production
Frac Operations Inspection Summary

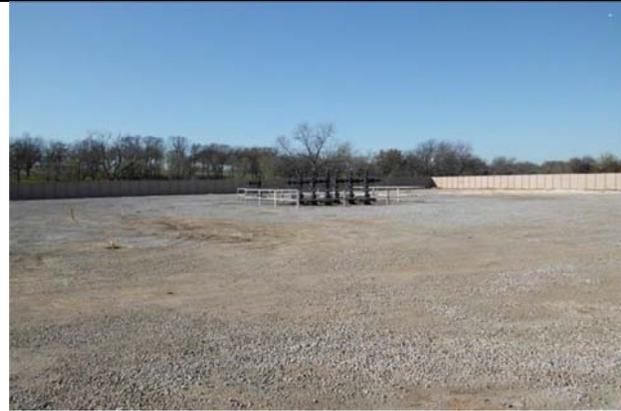
Looking South-West From Pad Entrance

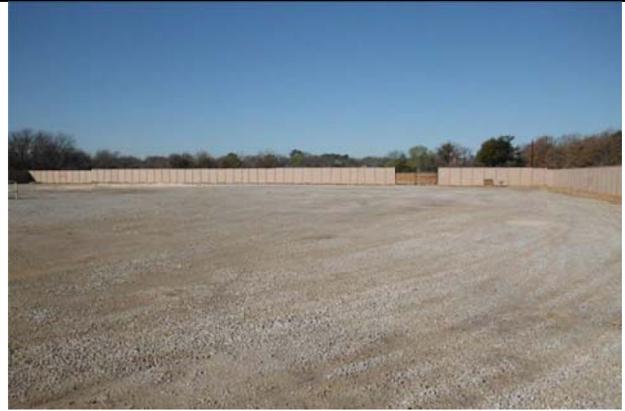
Looking West Across Pad

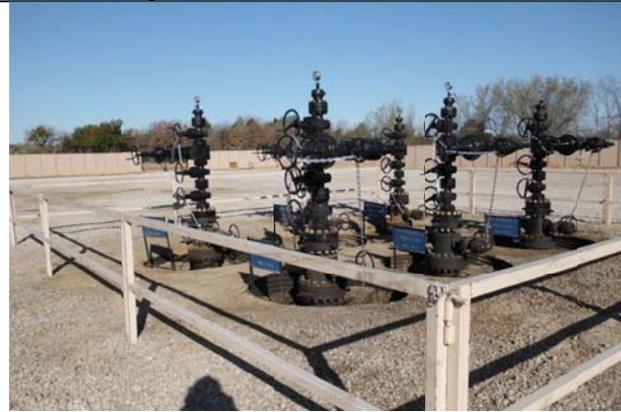
Wellheads E, F, A, D, I, B

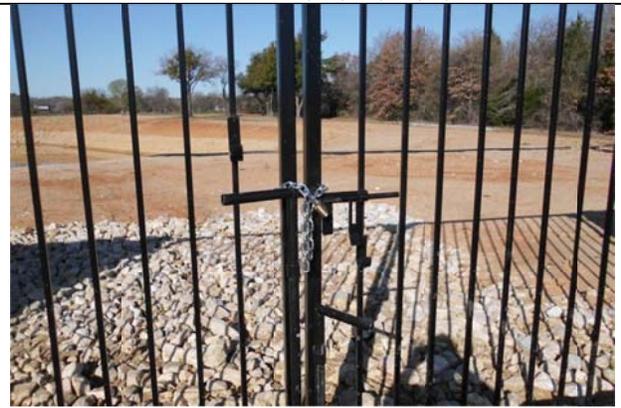
The fracing wellheads have been removed and the remaining equipment secured. The back gate has also been secured with chain and lock. Anchors are below grade and identified. Site appears in compliance with existing SUP and ordinances. Over the summer months un-sodded areas will develop plants and grasses which should be kept compatible with the surrounding property.

Back Gate - Secured

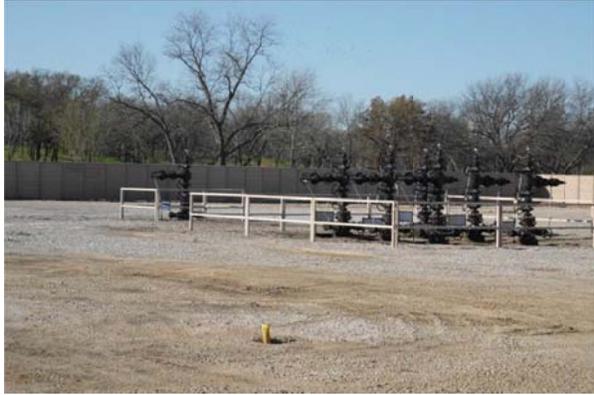
All Wellheads (note anchor flag in foreground)

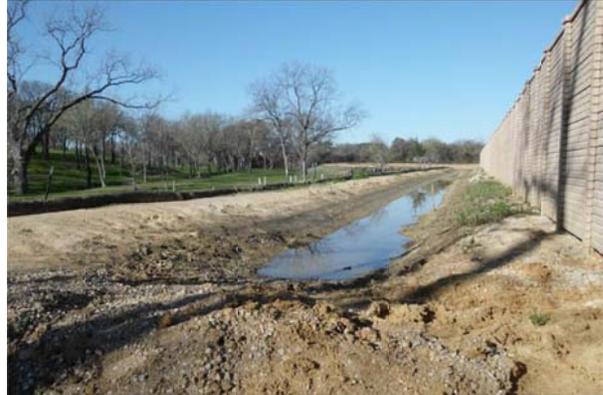
Area of Catchment Breach

Other than routine inspection, after heavy rain, the catchment area south of the pad site should be inspected where a breach on the east wall was experienced during one of the past heavy rain storms.

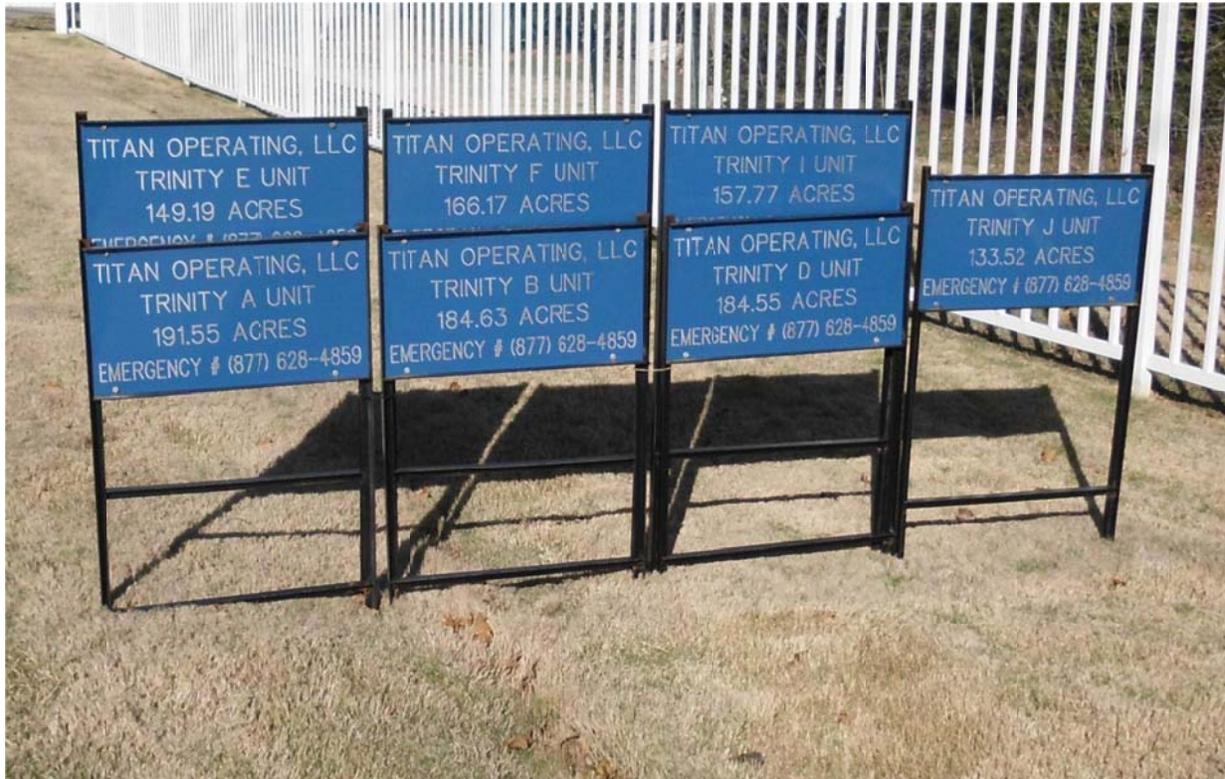
Required RRC Signage
