Re: Trinity Well Site Inspection Report

City of Colleyville Oil and Gas Well Drilling and Production – Inspection Report

Well/Pipeline Identification: Trinity
7504 Pleasant Run
Colleyville, Texas 76034

Date(s): March 1 – 8, 2011

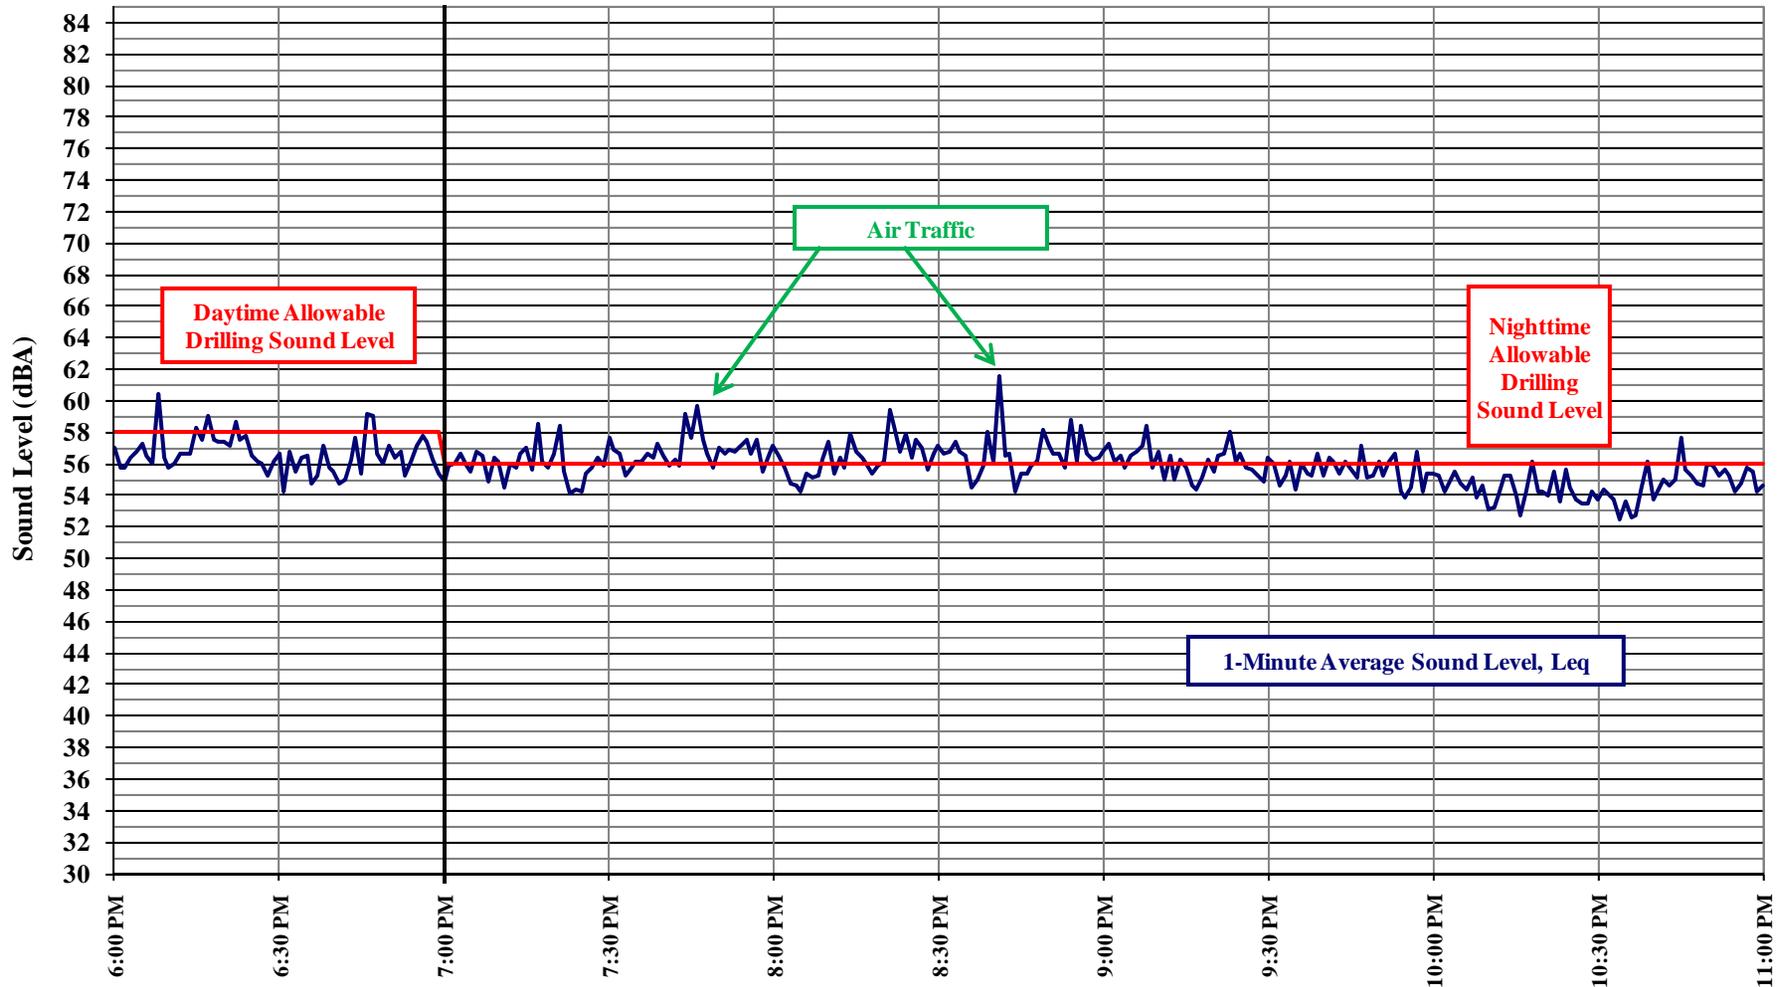
6:00 PM - 11:00 PM, March 7, 2011

The measured hourly sound levels were briefly out of compliance with the allowable drilling sound levels at Monitoring Location #1 during the monitoring period. Review of an audio recording made during the monitoring period revealed off-site noise from air traffic in the vicinity of the monitoring location as well as high winds, as the cause of the elevated sound levels.

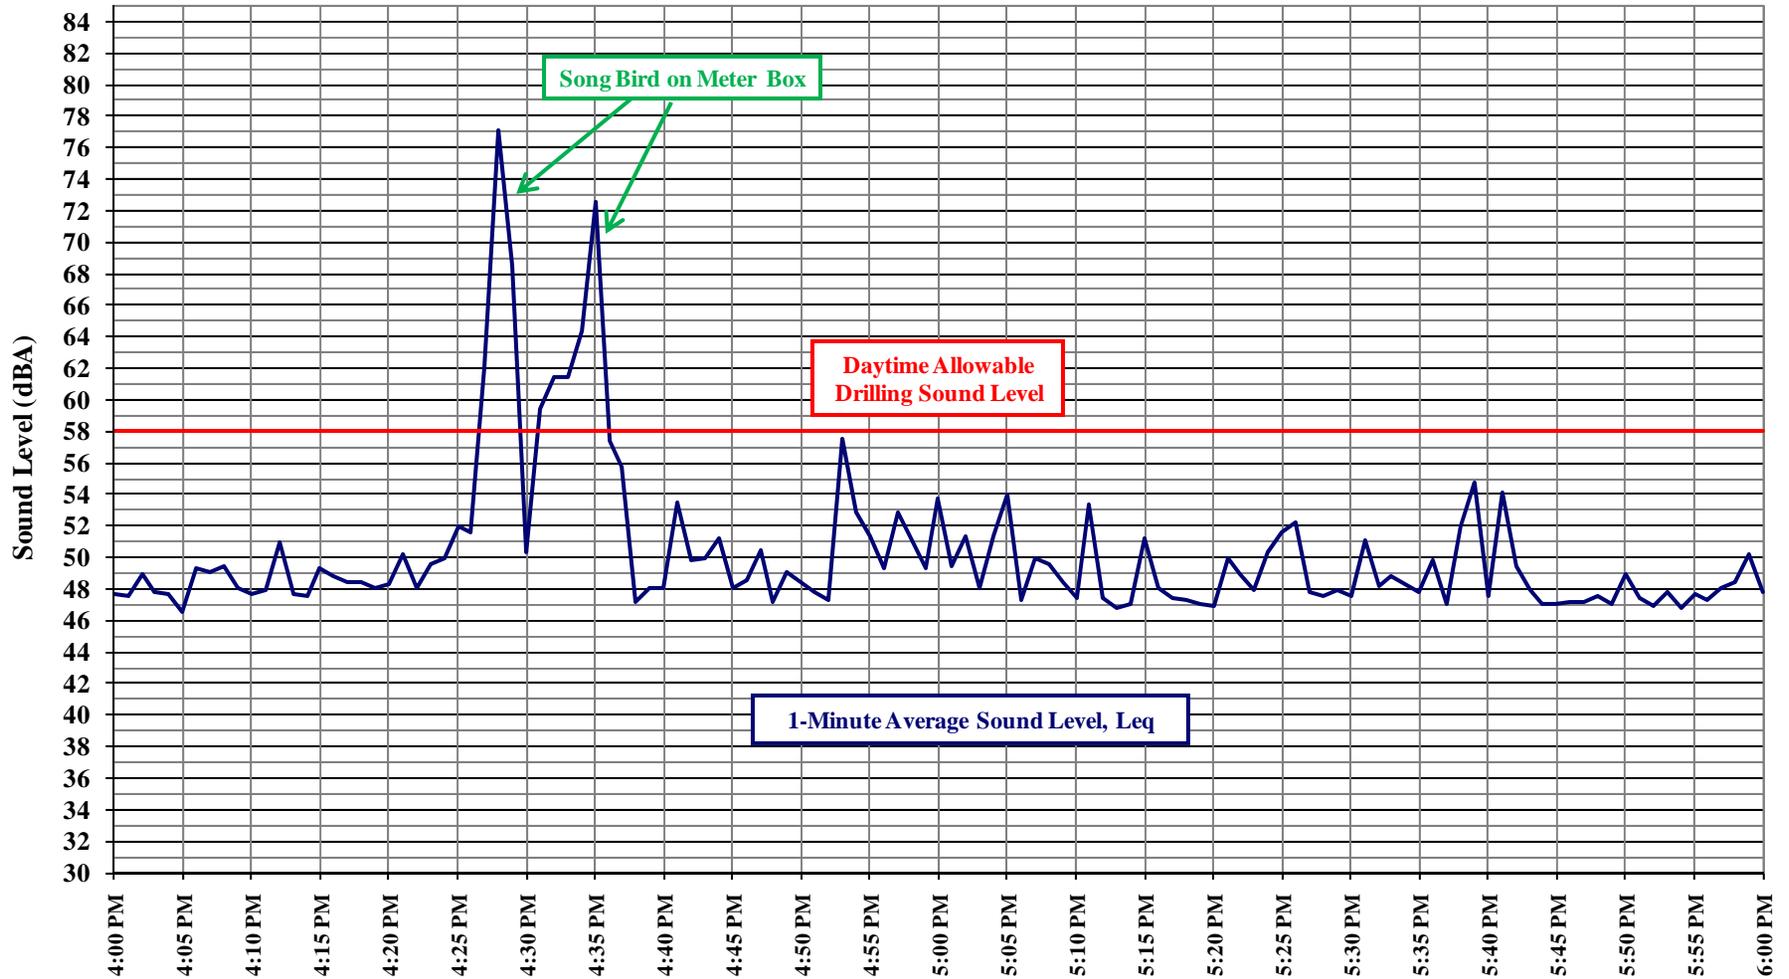
4:00 PM - 6:00 PM, March 8, 2011

The measured hourly sound levels were out of compliance with the allowable drilling sound levels at both monitoring locations during the monitoring period. At Monitoring Location #1, the measured sound levels were out compliance during the 4:00 PM hour on Tuesday, March 8, 2011. Review of an audio recording made during the monitoring period revealed off-site noise from a bird in the vicinity of the monitoring location as the cause of the elevated sound levels. Monitoring Location #2 was out of compliance with the allowable drilling sound levels during the 7:00 PM hour on Tuesday, March 8, 2011. Review of an audio recording made during the monitoring period revealed off-site noise from air traffic in the vicinity of the monitoring location as the cause of the elevated sound levels.
