Re: Trinity Well Site Inspection Report

City of Colleyville Oil and Gas Well Drilling and Production – Inspection Report

Well/Pipeline Identification: Trinity
7504 Pleasant Run
Colleyville, Texas 76034

Date(s): March 1 – 8, 2011

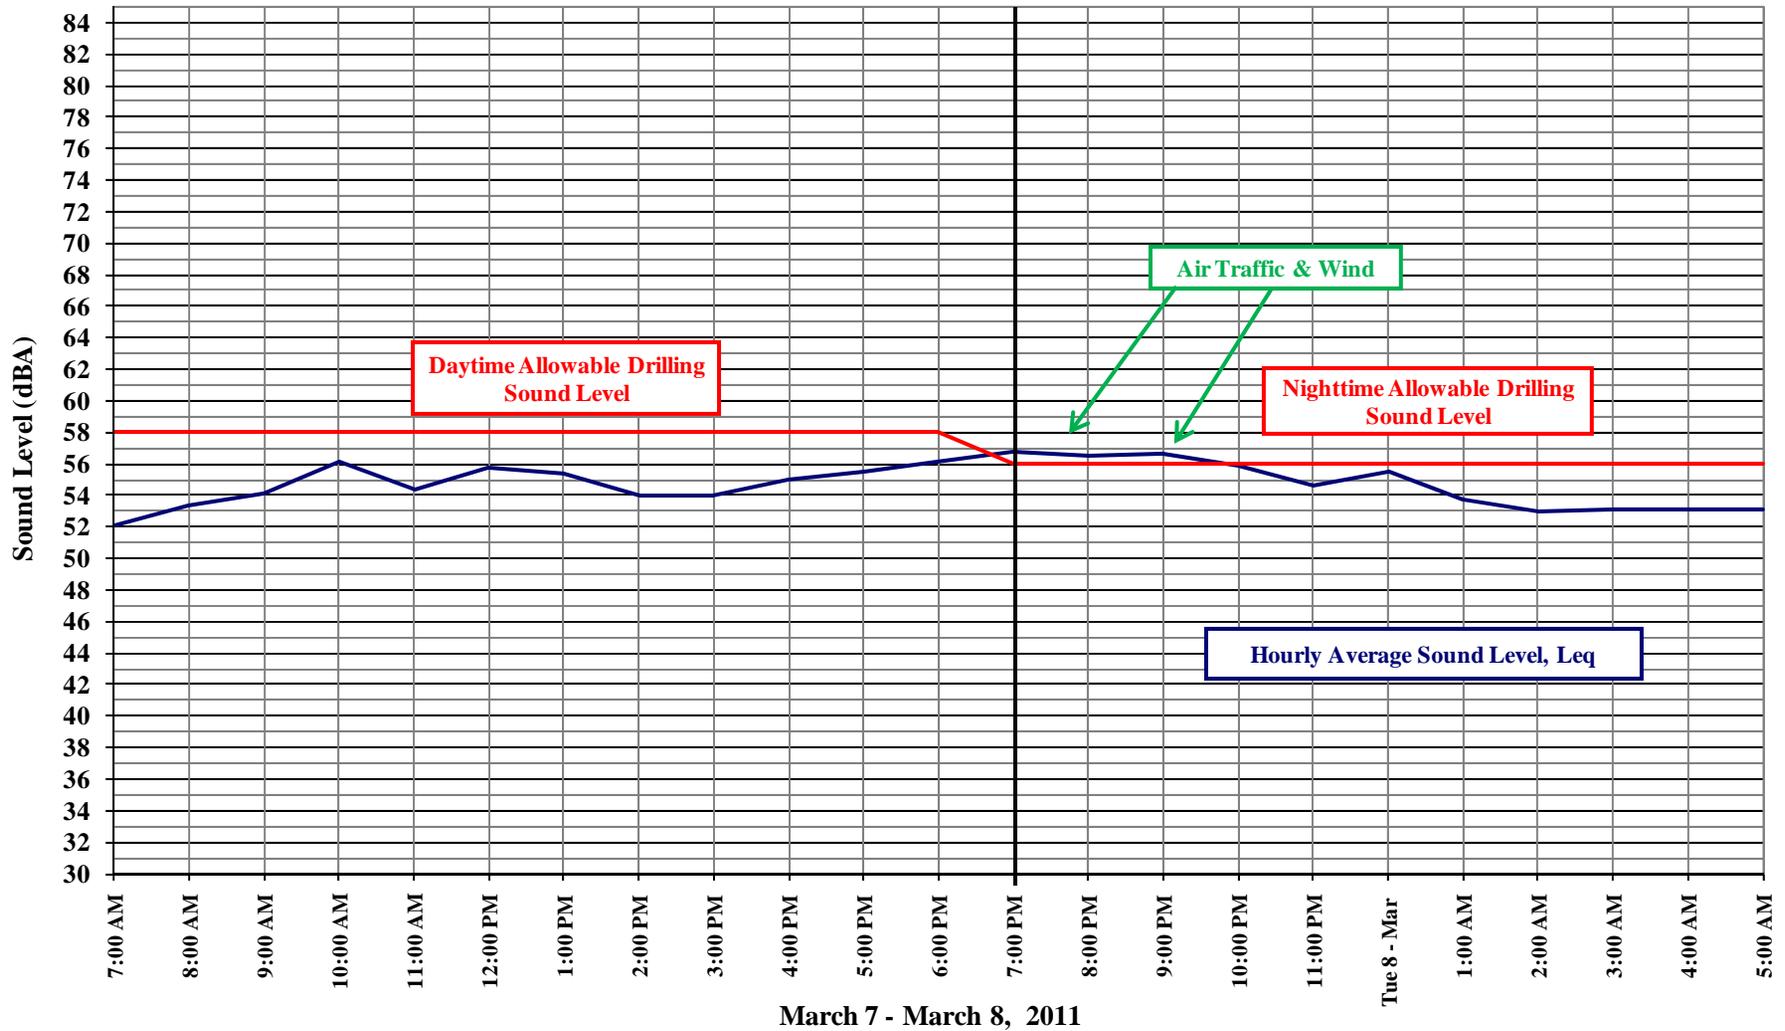
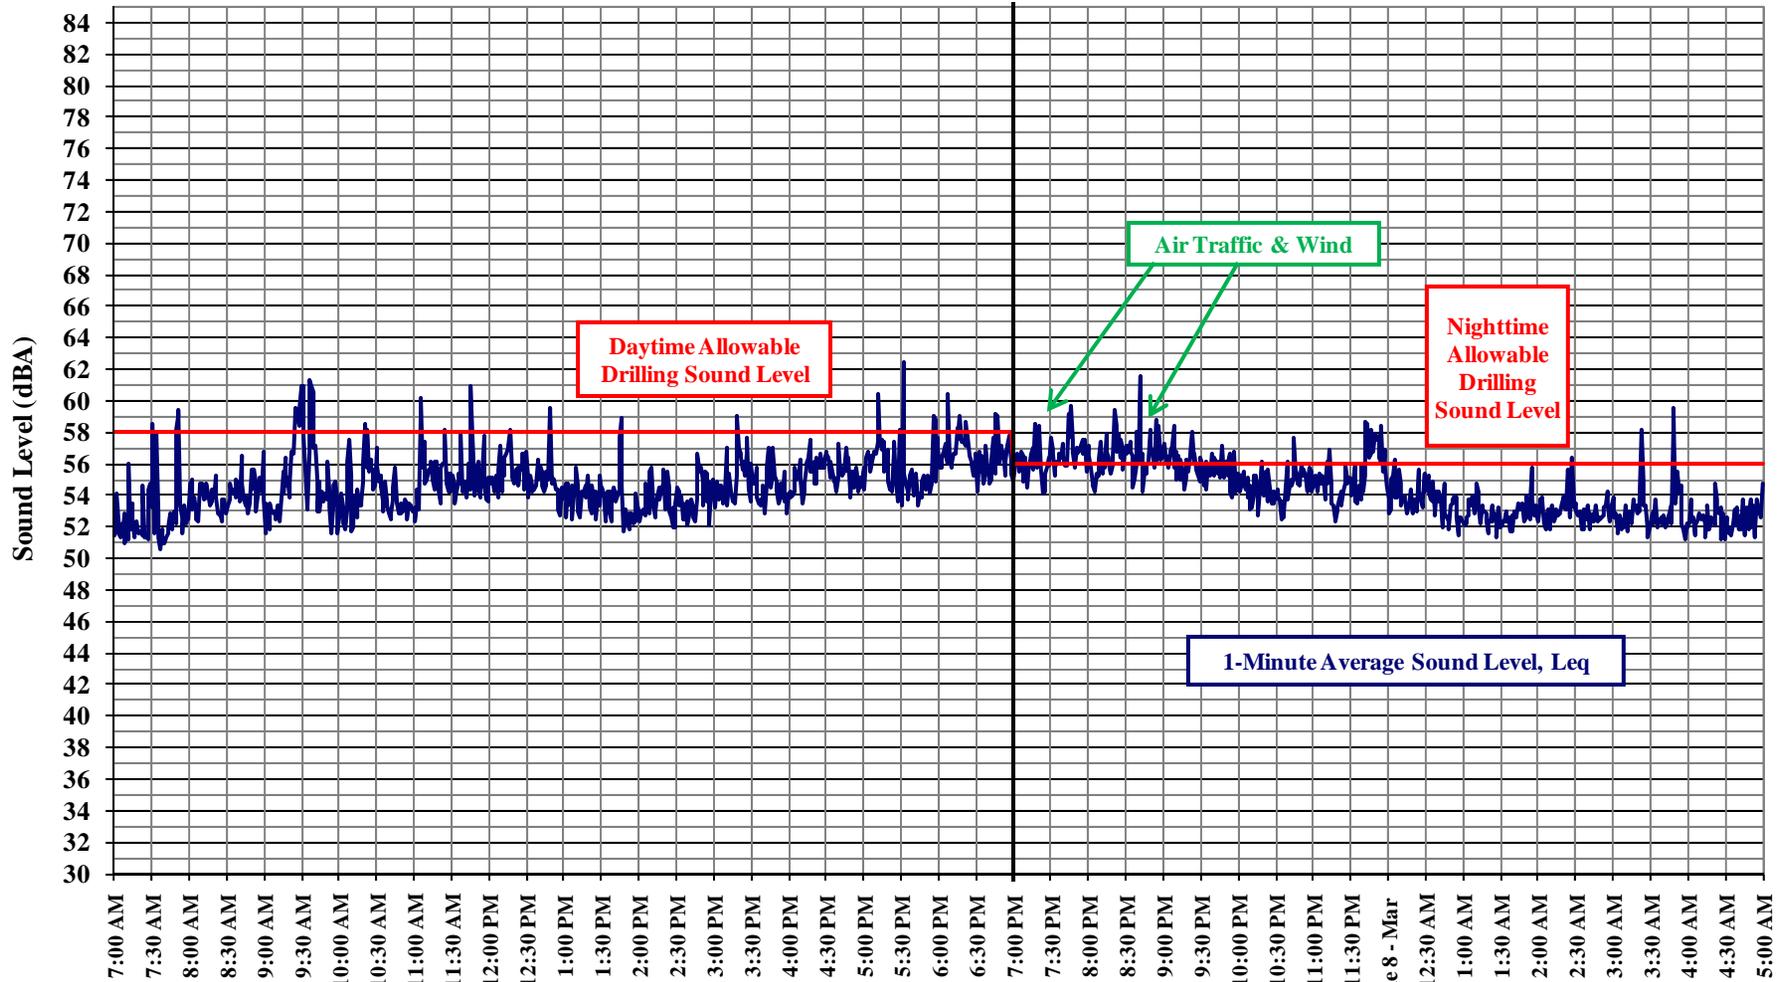
Titan Operating TCC 1H Drill Site - Monitoring Location #1 Continuous Sound Level Monitoring

The measured hourly sound levels were briefly out of compliance with the allowable drilling sound levels at Monitoring Location #1 during the monitoring period. Review of an audio recording made during the monitoring period revealed off-site noise from air traffic in the vicinity of the monitoring location as well as high winds, as the cause of the elevated sound levels.

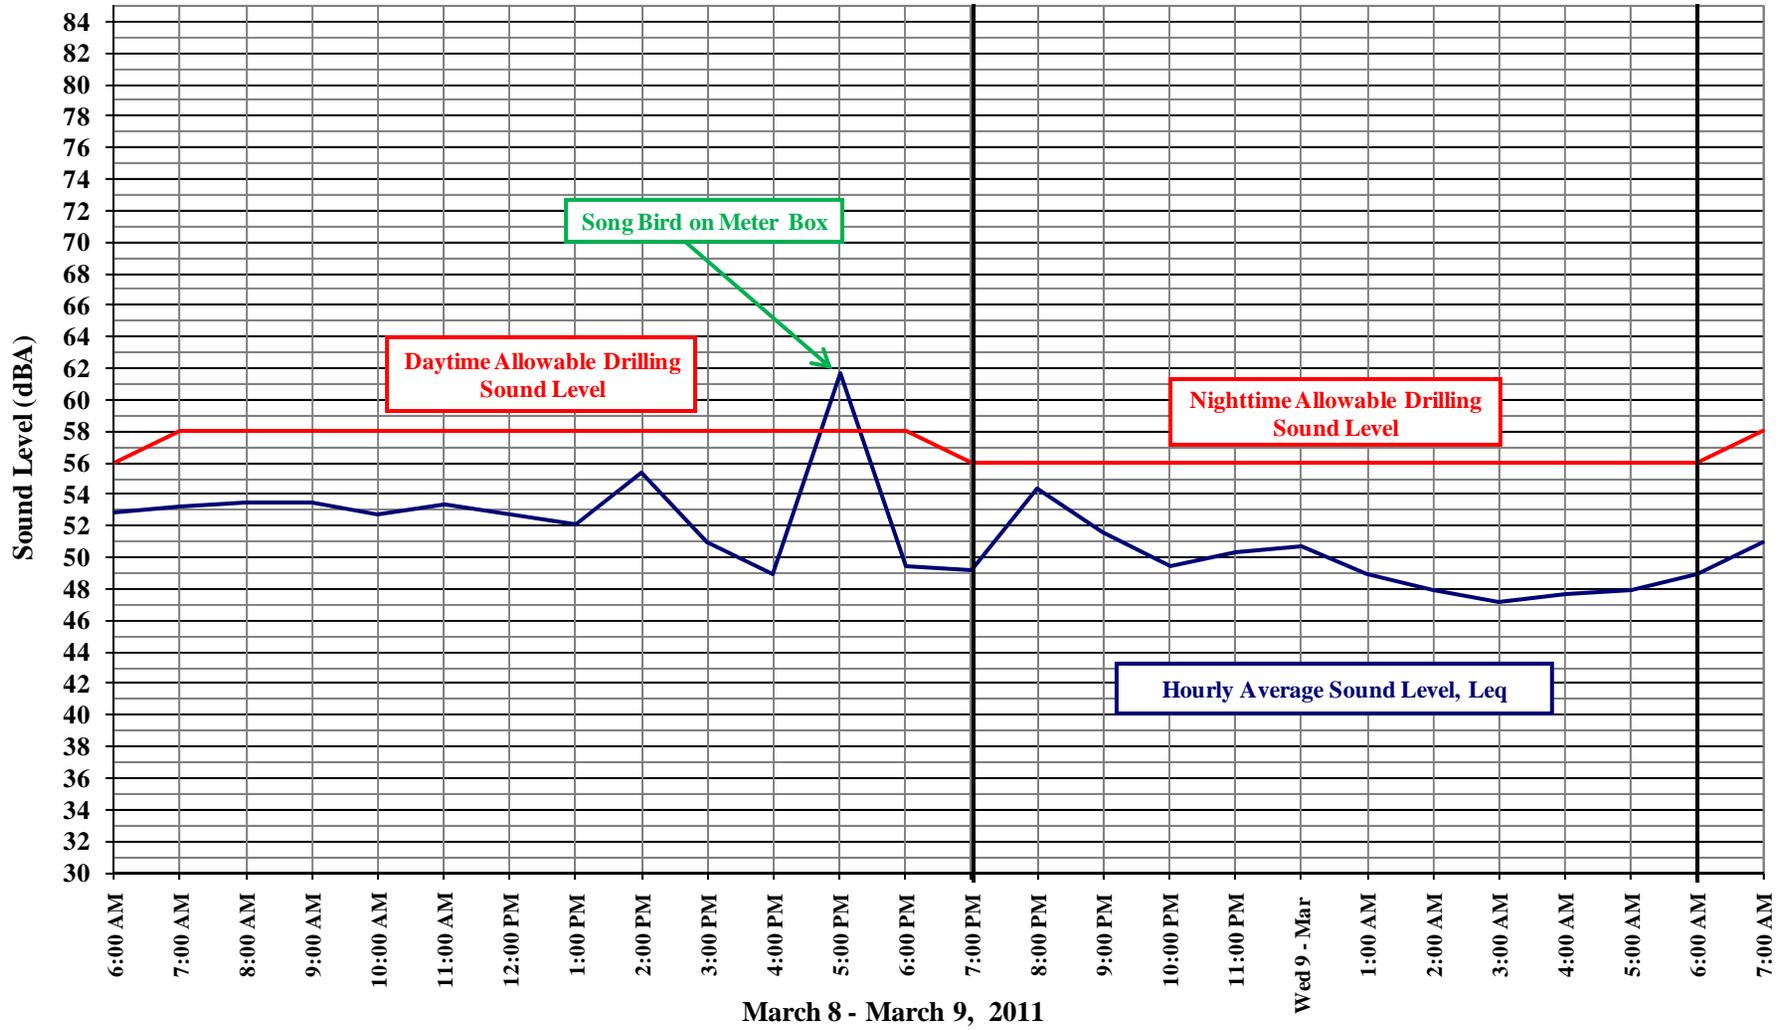
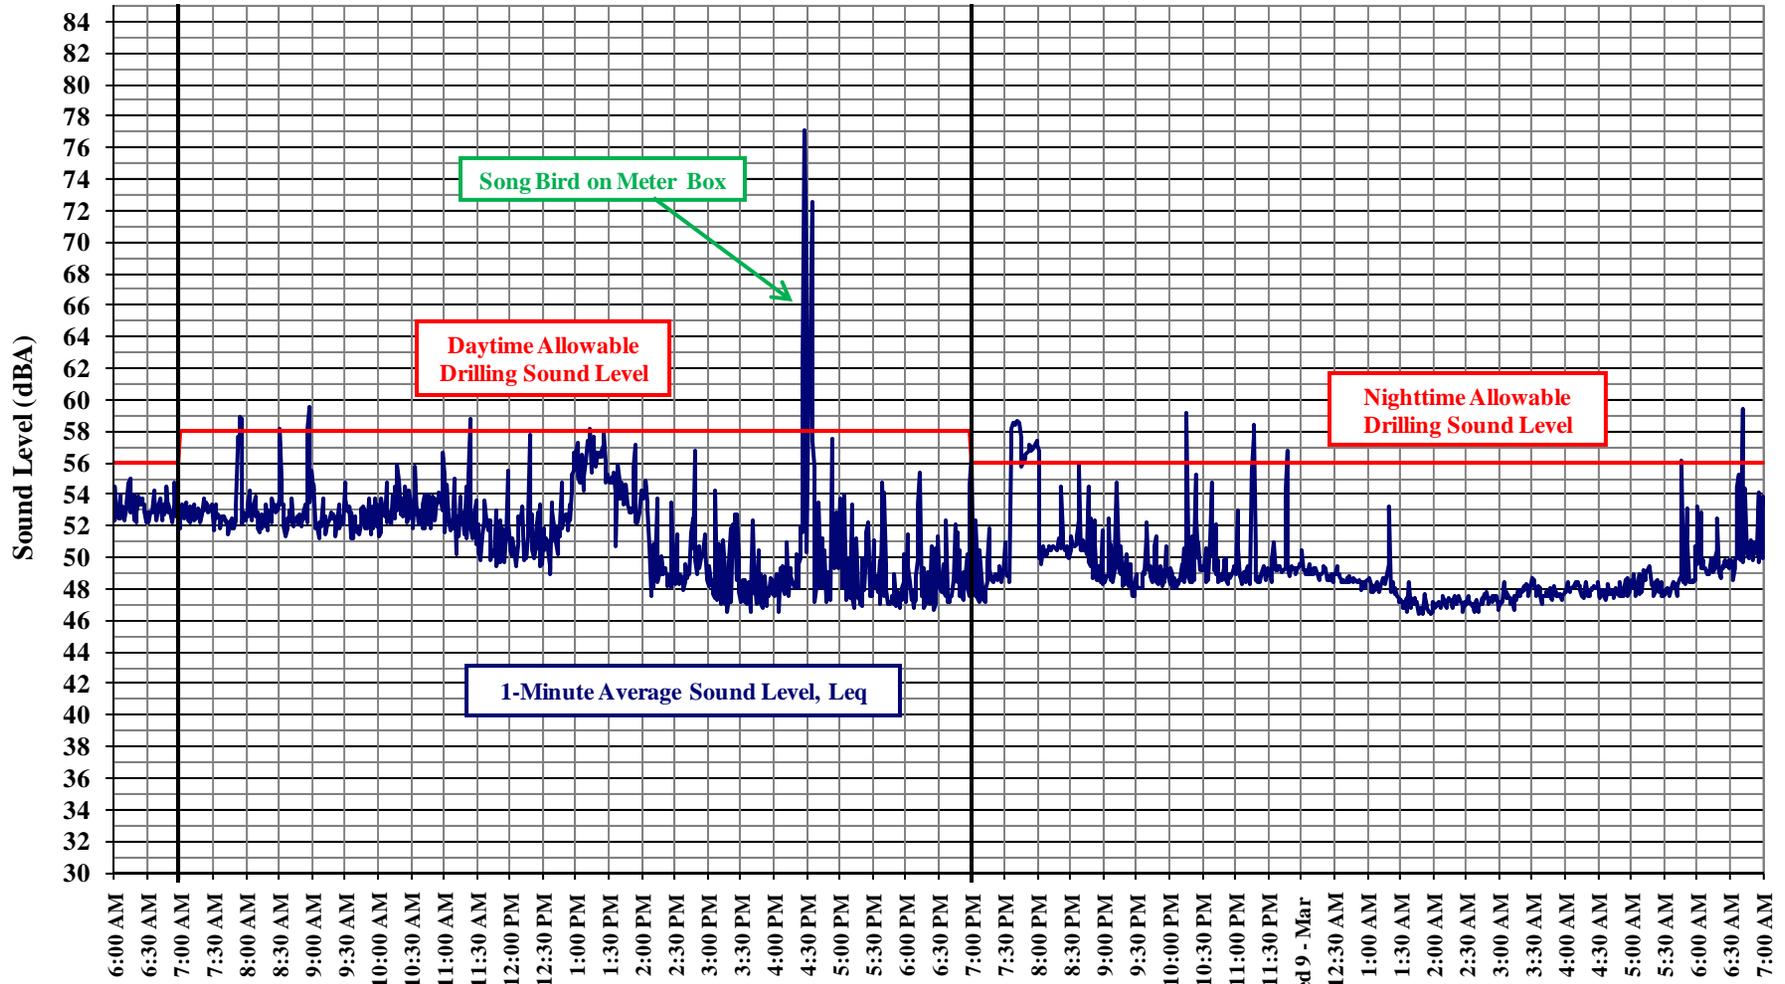
Titan Operating TCC 1H Drill Site - Monitoring Location #1 Continuous Sound Level Monitoring

The measured hourly sound levels were out of compliance with the allowable drilling sound levels at both monitoring locations during the monitoring period. At Monitoring Location #1, the measured sound levels were out compliance during the 4:00 PM hour on Tuesday, March 8, 2011. Review of an audio recording made during the monitoring period revealed off-site noise from a bird in the vicinity of the monitoring location as the cause of the elevated sound levels. Monitoring Location #2 was out of compliance with the allowable drilling sound levels during the 7:00 PM hour on Tuesday, March 8, 2011. Review of an audio recording made during the monitoring period revealed off-site noise from air traffic in the vicinity of the monitoring location as the cause of the elevated sound levels.
